Balcony Venue™ Series

JBL Loudspeaker Troubleshooting/Repair Tips

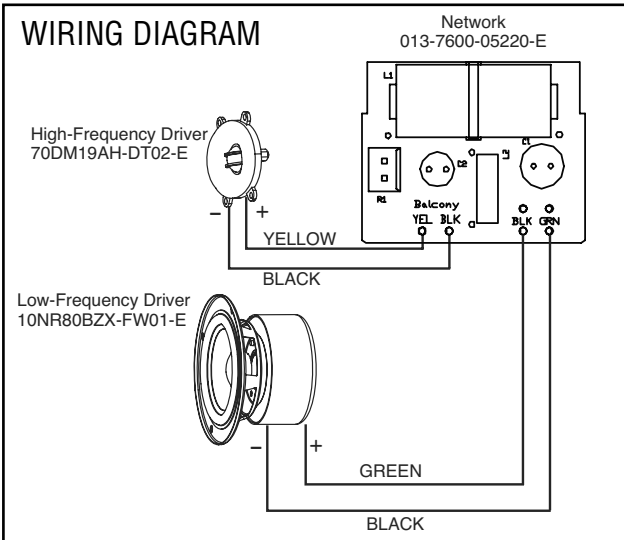
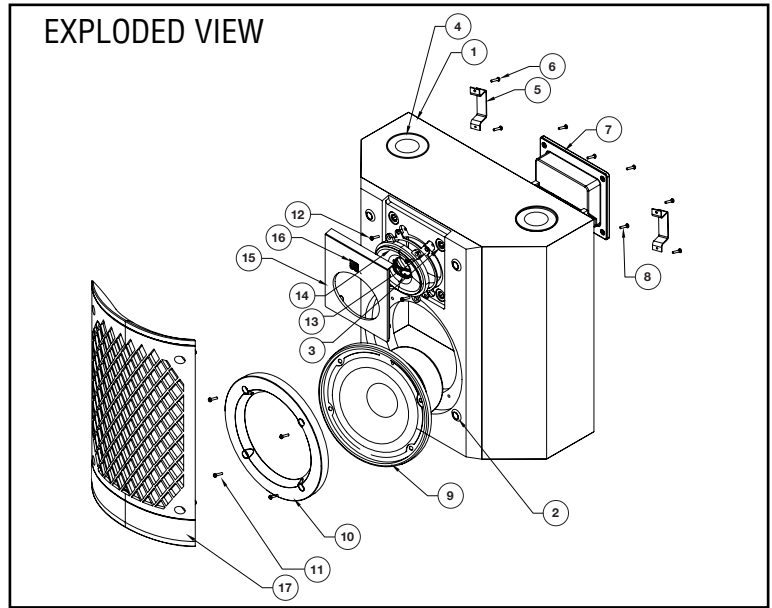
Refer to the wiring diagram and exploded view below. The network is a small circuit board found on the inside of the terminal cup, or mounted to an inside wall of the enclosure. It sends low-frequency sounds to the woofer, high-frequency sounds to the tweeter and, if applicable, mid-frequency sounds to the midrange driver. Make sure all wires are secure and connected. Look for components on the network that look burnt, "bulged," or abnormal. If everything looks normal, connect the network to the drivers from another matching loudspeaker. **MAKE SURE** you attach the correct wires to each driver – mid- and low-frequency sounds can damage the tweeter! If there is still no sound or distorted sound, the network is defective. If there is clean undistorted sound, the drivers are defective.

The tweeter on the JBL Balcony resides behind the silver faceplate affixed to the front baffle with a pin/cup arrangement similar to a front grille. After the grille removal, to access the tweeter, use a box cutter, knife or similar tool to work the top portion of the silver faceplate away from the front baffle - **USE CAUTION**. Once the top edge is detached (see image), work the tool carefully down the length of the faceplate until it can be removed completely. If the faceplate is accidentally damaged during this process, order JBL part number 301-ABS-05043-0VAE.
