JBL Northridge E60

JBL Loudspeaker Troubleshooting/Repair Tips

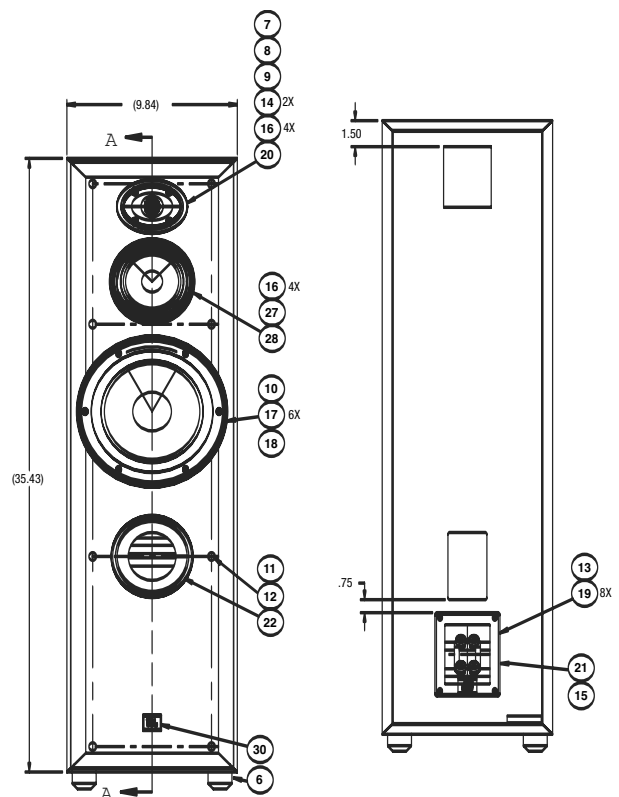
PARTS LIST
