Voice Venue™ Series

JBL Loudspeaker Troubleshooting/Repair Tips

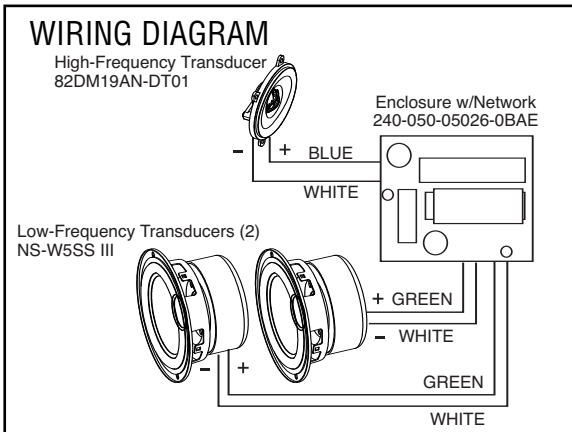
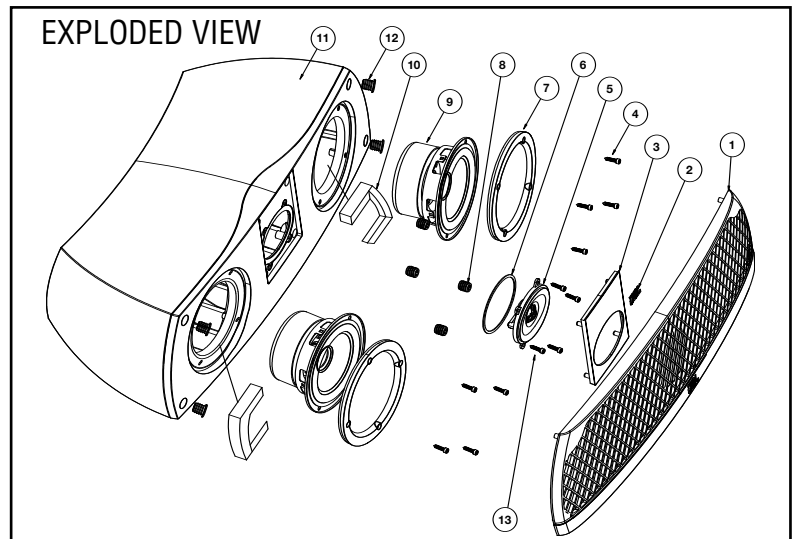
Refer to the wiring diagram and exploded view below. The network is a small circuit board found on the inside of the terminal cup, or mounted to an inside wall of the enclosure. It sends low-frequency sounds to the woofer, high-frequency sounds to the tweeter and, if applicable, mid-frequency sounds to the midrange driver. Make sure all wires are secure and connected. Look for components on the network that look burnt, "bulged," or abnormal. If everything looks normal, connect the network to the drivers from another matching loudspeaker. **MAKE SURE** you attach the correct wires to each driver – mid- and low-frequency sounds can damage the tweeter! If there is still no sound or distorted sound, the network is defective. If there is clean undistorted sound, the drivers are defective.

Note: A Phillips screwdriver and 3mm Allen wrench (hex key) are required to service this product.

ITEM NO.	PART NO.	DESCRIPTION	QTY.	ITEM NO.	PART NO.	DESCRIPTION	QTY.
1	244-050-05199-0VAE	FRONT GRILLE	1	11	240-050-05026-0BAE	ENCLOSURE (INCLUDES NETWORK AND BINDING POSTS)	1
2	316-FE-05146-0VAE	JBL LOGO	1	12	327-010-00622-E	GRILLE RETAINER	4
3	233-020-05111-0VAE	TWEETER FACEPLATE	1	13	352-AM03512D278-E	TWEETER SCREW	4
4	352-KM04016D189-E	WOOFER SCREW	8	14	406-000-05323-E	OWNER'S MANUAL	1
5	82DM19AN-DT01	TWEETER	1	15	405-000-00050-E	WARRANTY CARD	1
6	333-EVA-05257-0BAE	TWEETER GASKET	1	16	373-RUB-00004-E	RUBBER FEET (SET)	1
7	213-050-05093-0VAE	WOOFER TRIM RING	2	17	(NOT FOR SALE)	COTTON BAG	1
8	338-RUB-05033-0BAE	FACEPLATE RETAINERS (TWEETER)	4	18	431-000-05558-E	POLYFOAM (SET)	1
9	NS-W5SS III	5" WOOFER	2	19	402-000-05481-E	OUTER CARTON	1
10	(NOT FOR SALE)	DAMPING MATERIAL	2

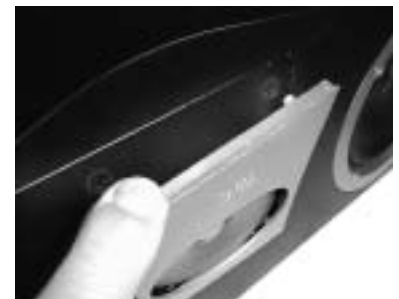
TWEETER SERVICING:

The tweeter on the JBL Voice resides behind the silver faceplate affixed to the front baffle with a pin/cup arrangement similar to a front grille. After the grille removal, to access the tweeter: Use a box cutter, knife or similar tool to work the top portion of the silver faceplate away from the front baffle – **USE CAUTION**. Once the top edge is detached (see image), work the tool carefully down the length of the faceplate until it can be removed completely. (If the faceplate is accidentally damaged during this process, order JBL part number 233-020-05111-0VAE.)
